State of Utah DEPARTMENT OF NATURAL RESOURCES Division of Oil, Gas & Mining

Inspection Report Minerals Regulatory Program April 16, 2012

Mine Name: Italian Tan	Permit Number: S/007/0038		
Operator Name: Quality Building Stone	Inspection Date: 04/04/2012		
Inspector(s): Wayne Western	Time: 9:00- 9:45 AM		
Other Participants:	Mine Status: ACT		
Weather Condition: Cool and clear skies	Last Inspection: 3/30/2011		
Bond Renewal Date: 07/22/2006	Bond Amount: \$12,500		
Surface Ownership: Fee	Mineral Ownership: Fee

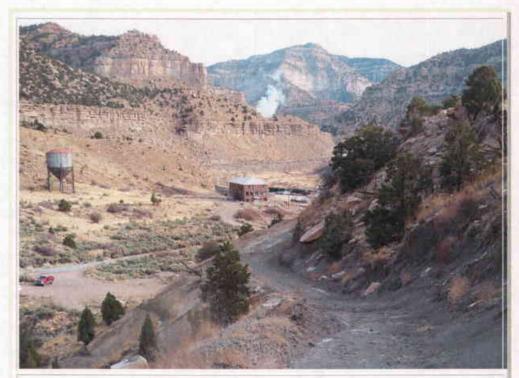
The main roads were reclaimed. The roads were left in a condition so that the landowner could still access them. The roads had diversion ditches to reduce erosion and associated rills and gullies. The road will be evaluated at final reclamation.

Road reclaimed

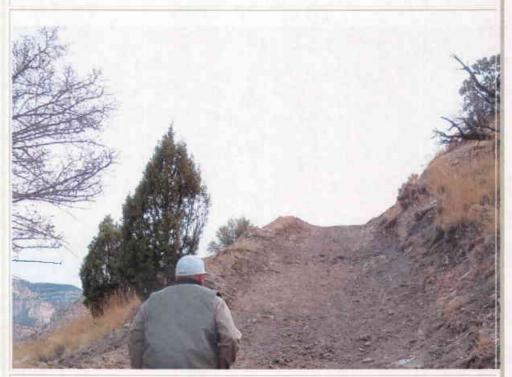
Roads reclaimed.

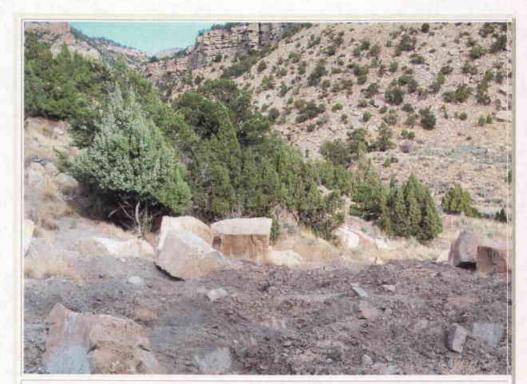
The Permittee installed diversion ditches to prevent erosion on the reclaimed roads. Non road areas were pocked to control erosion and promote vegetation.

Pocked area and boulder placement.

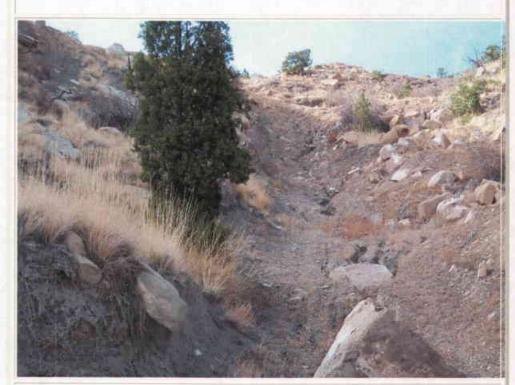
After the inspection, I showed Paul Baker pictures of the site. Paul Baker and I compared the photographs taken during the inspection with those taken before reclamation. There is one section of the area that was not reclaimed and has rills and gullies. The Division contacted Velina Miller, she claims that the site was left according to instructions given them by the landowner, Utah Railway.

Disturbed area that was not reclaimed.

The Division will wait to hear from the landowner prior to granting final bond release.

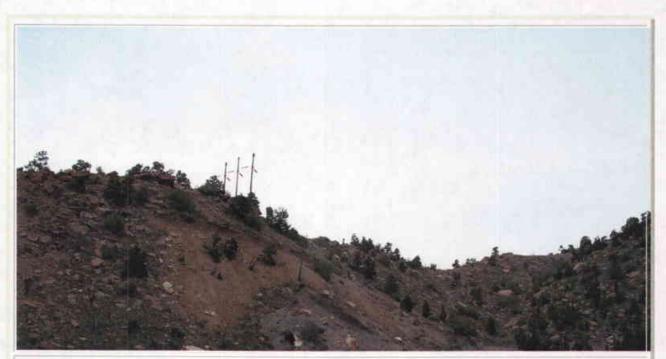
Picture taken May 5, 2005 shows that area was not disturbed as of that date.

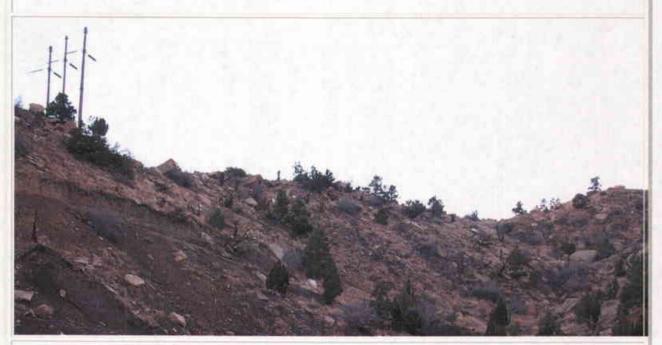
Picture taken November 18, 2004 shows the area had not been disturbed as of that date.
